Manhole Inspection Summary

Manhole # S21WW1035MH

Insp Date: **11/29/06 3:53 PM**

Location Address: **30 BOUTON GREEN CT**

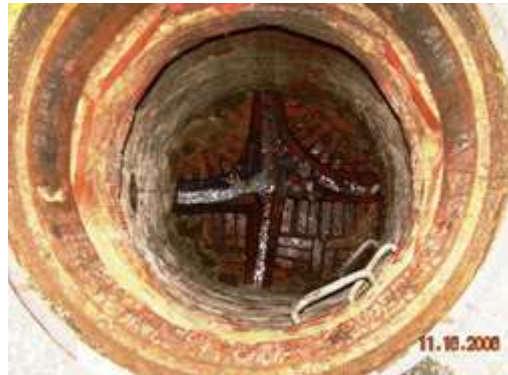
Top View

Bench debris.

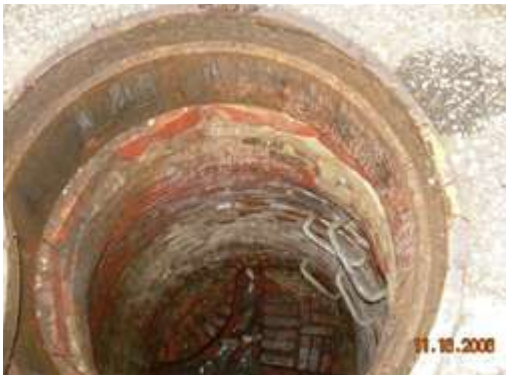
Defect

☒ **Leaks**

Condition: ☐ Sound ☐ Cracked ☐ Root Intrusion ☐ Loose Brick ☒ **Deteriorated**

Infiltration: ☐ None ☒ **Joint** ☐ Cracks ☒ **Mortar** ☐ Roots ☐ Wall

Infiltration: ☐ None ☐ Joint ☐ Cracks ☒ **Mortar** ☐ Roots ☒ **Wall**

Frame leaks. Adjustment deterioration and infiltration. Barrel infiltration.

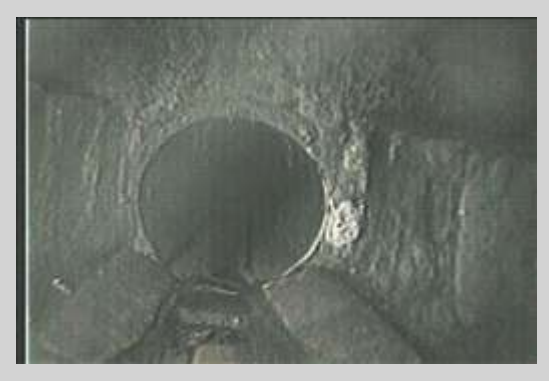
6 in. Circular Gravity Sewer Pipe Out @ 12 O'Clock

Invert Depth: **9.59** (ft.) Flow Characteristics: **Slow**

Deposits: ☒ None ☐ Mud ☐ Sludge ☐ Debris ☐ Grease

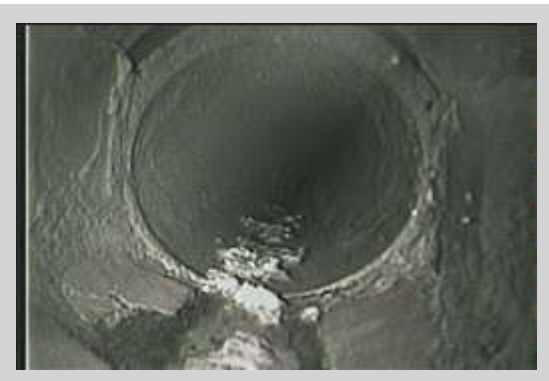
6 in. Circular Gravity Sewer Pipe In @ 3 O'Clock

Deposits: ☐ None ☐ Mud ☐ Sludge ☒ Debris ☒ Grease

Silt Depth: **0** (in.) Deposits Extent: **Light**
